MARYLAND INVENTORY OF HISTORIC BRIDGES
HISTORIC BRIDGE INVENTORY
MARYLAND STATE HIGHWAY ADMINISTRATION/
MARYLAND HISTORICAL TRUST

MHT No. HO-730

SHA Bridge No. 13026 Bridge name Md 32 Pedestrian Bridge over Middle Patuxent River

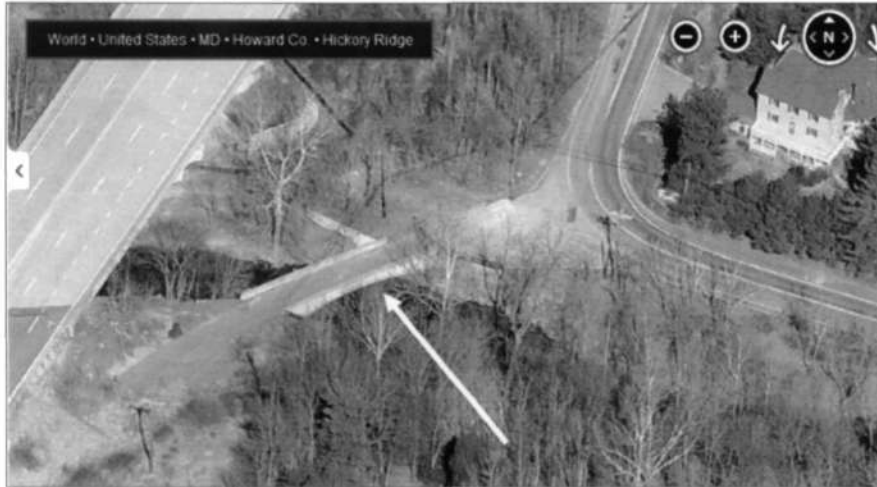
Bridge #13026. Pedestrian Bridge over Middle Patuxent River
Bing Maps Bird's-eye view

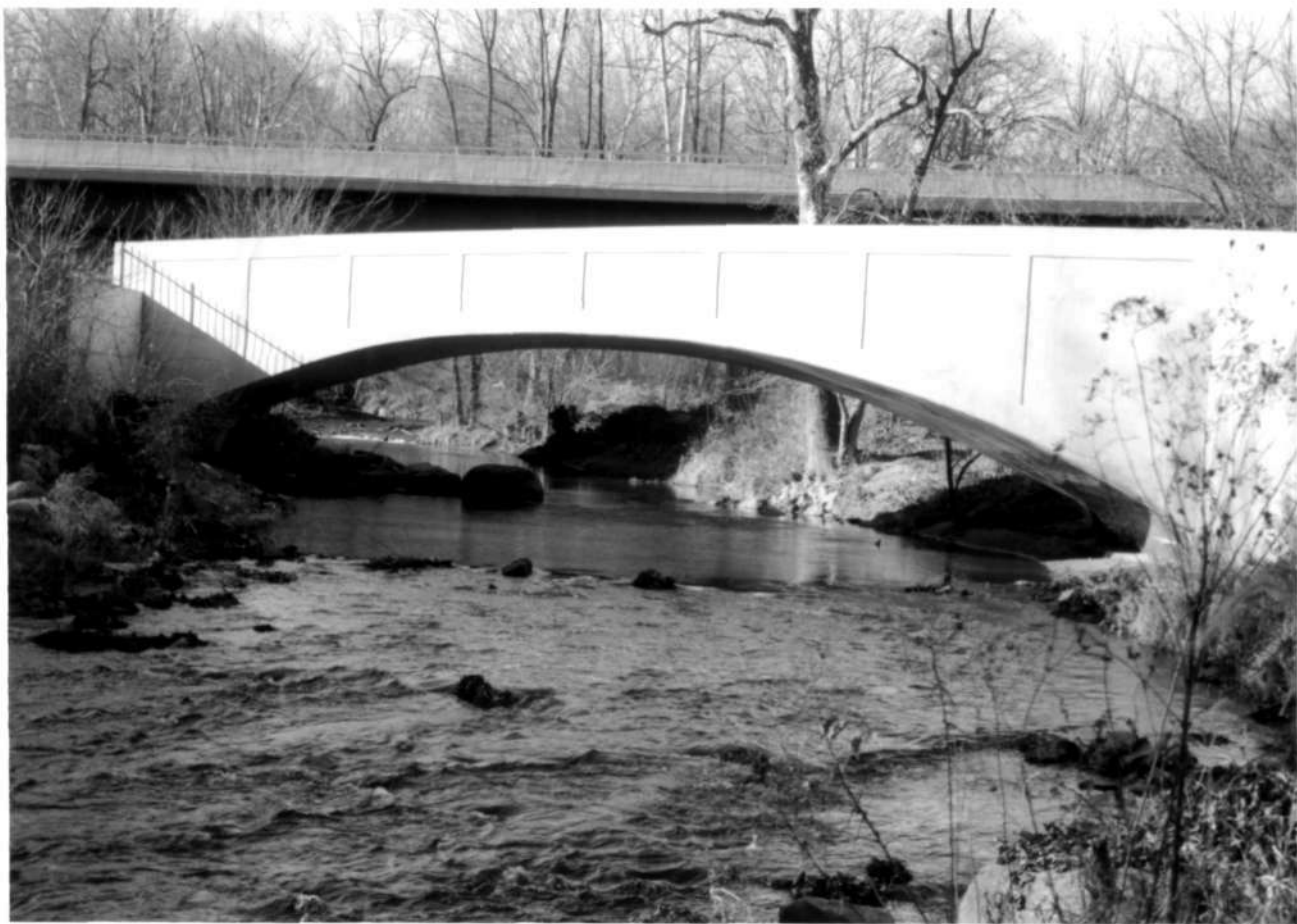
1. HO-730
2. MD32 Pedestrian Bridge over Middle Patuxent River
3. Howard Co., MD
4. Wallace, Montgomery & Assoc.
5. 12/97
6. MD SHPO
7. Elevation looking downstream
8. 2 of 4

Bridge 13026 is a single-span, concrete arch bridge. The bridge was constructed in 1916, was widened with metal beams in 1971, and was reconstructed circa 1995 to restore the original appearance of the bridge. The structure is 25.3 meters (83 feet) long and has a clear roadway width of 9.4 meters (31 feet). The out-to-out width is 10 meters (33 feet). The superstructure consists of 1 arch which supports a concrete deck and concrete parapets. The arch spans 24.1 meters (79 feet) and is a filled spandrel concrete arch. The concrete deck has a bituminous wearing surface. The structure has solid parapets and the roadway approach is gated on the east. The substructure consists of 2 concrete abutments. There are 4 flared concrete wingwalls. The bridge not posted, and does not have a sufficiency rating.

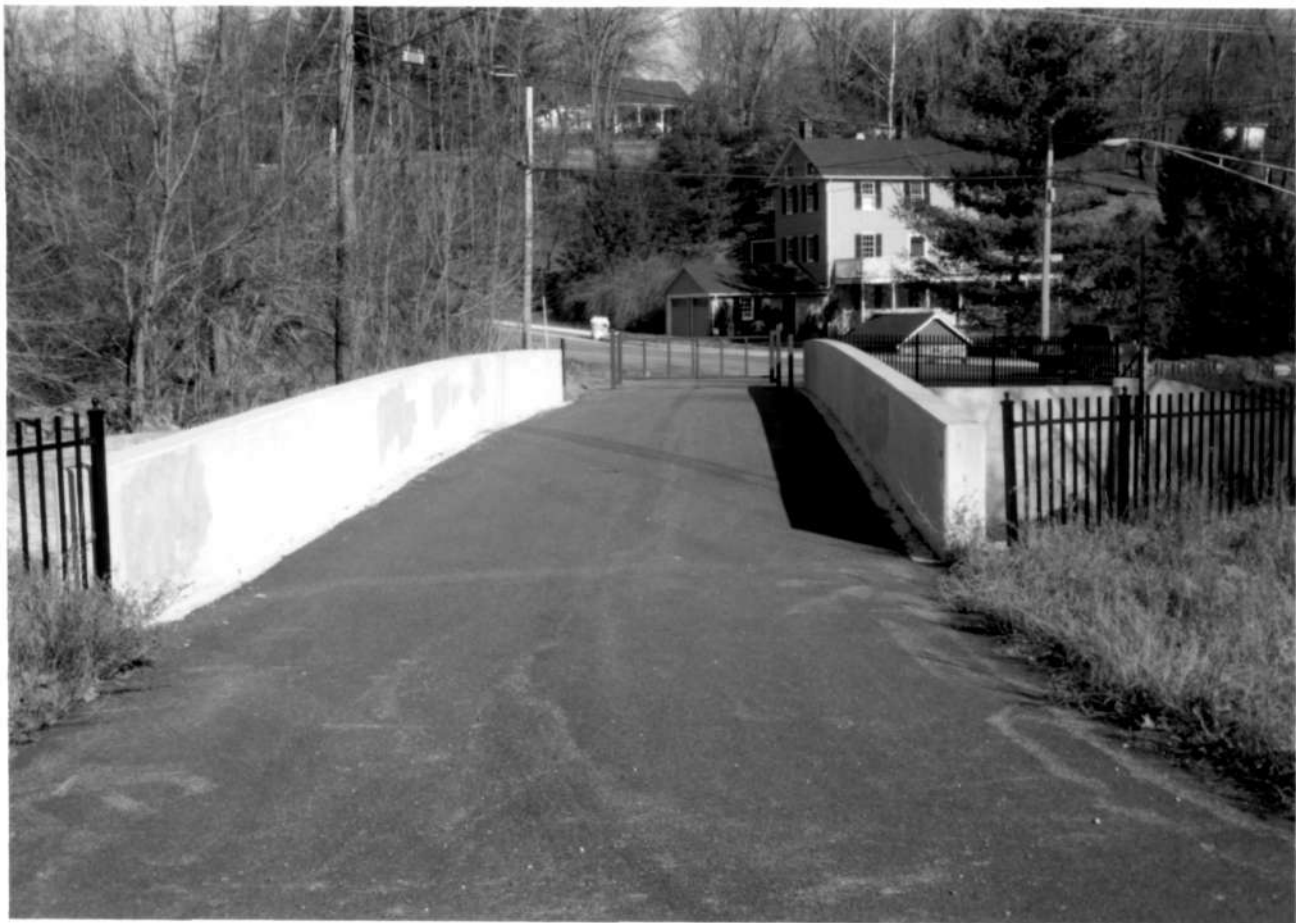
1. HO-730
2. MD 32 Pedestrian Bridge over Middle Patuxent River
3. Howard Co., MD
4. Wallace, Montgomery & Associates
5. 12/97
6. MD SHPO
7. Looking East
8. 3 of 4

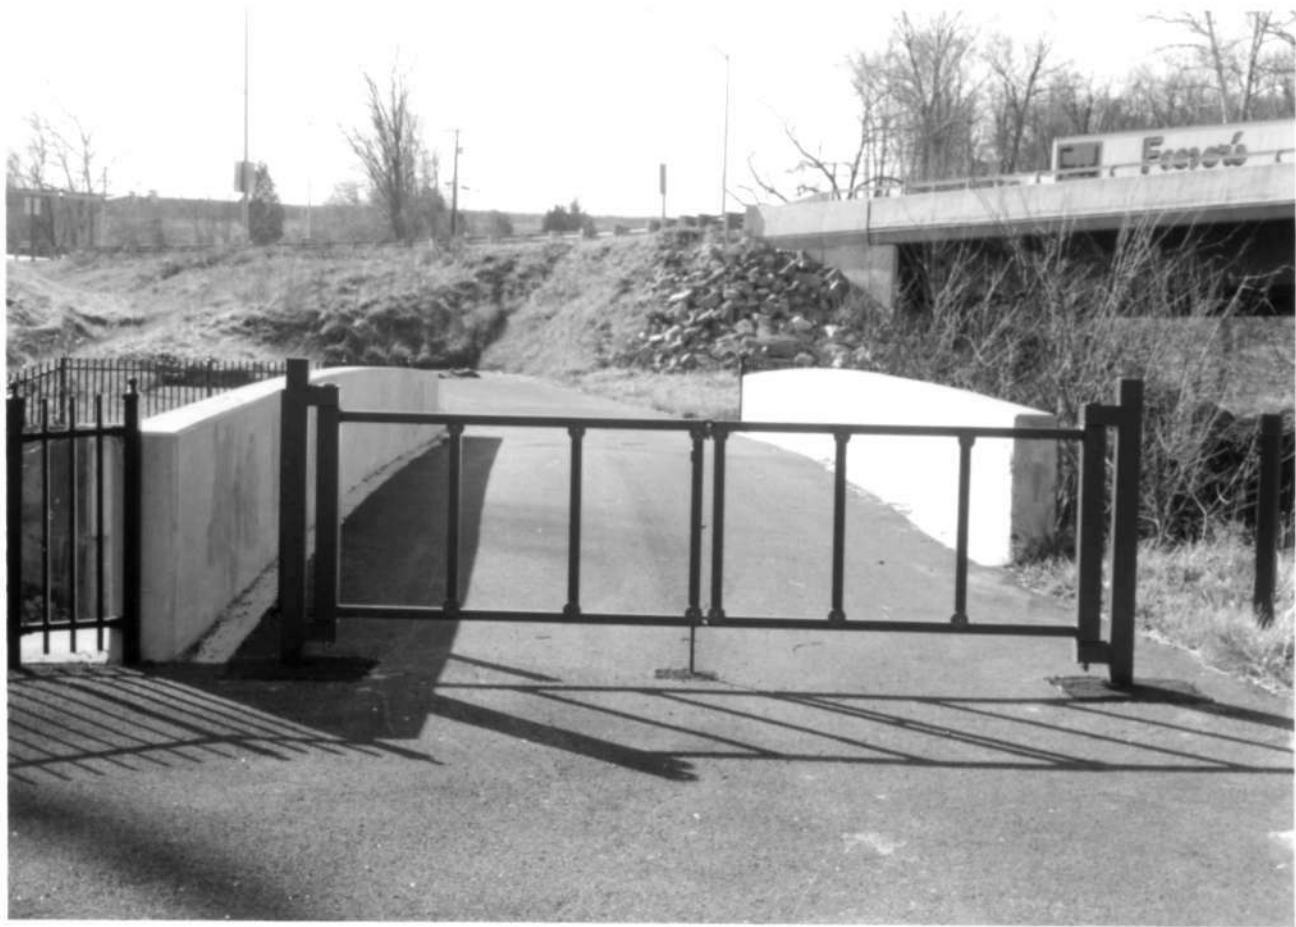
1. HO-730
2. MD 32 Pedestrian Bridge over Middle Patuxent River
3. Howard Co., MD
4. Wallace, Montgomery & Associates
5. 12/97
6. MD SHPO
7. Looking West
8. 4 of 4
